Update on the erosion of the St Francis Bay Marina spit/dune

by Dr Werner K Illenberger
November 2008

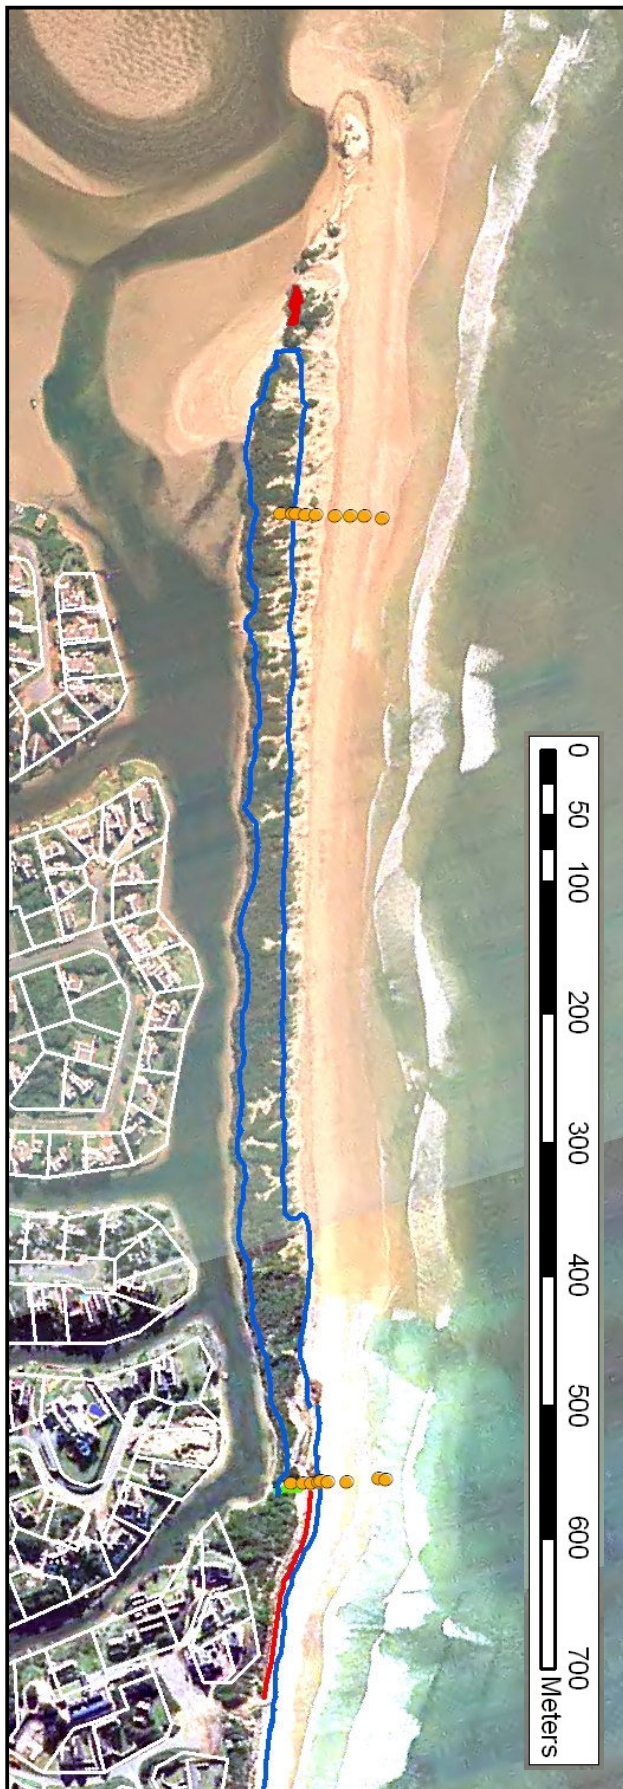
The map on the next page shows the erosion that has taken place from 2003 to October 2008. The northern end of the spit is eroding fastest, and the tip is being broken into “islands” that are easily destroyed by wave erosion, shortening the spit.

The base photograph in this map shows the spit/dune between Ski Canal of St Francis Bay Marina and the open ocean in 2003.

The blue line shows the spit/dune in October 2008. The northern end is eroding fastest, and the tip is being broken into “islands” that are easily destroyed by wave erosion, shortening the spit. The island formed during the extreme wave storm of 1 September 2008 is shown in red.

The conclusions regarding the current situation are the same as last year; *a rock revetment should be built as an emergency measure to stop the erosion of the spit/dune*, except that ***the urgency is increased***, particularly because the northern tip of the spit is being destroyed rapidly.

The construction work that will be needed in the event of the spit/dune breaching before the rock revetment is built will be much more expensive and difficult. The rock revetment should thus be built as soon as possible.
